**BUREAU OF SHIPS GROUP
TECHNICAL INSPECTION REPORT**

OPERATION CROSSROADS.
U.S.S. LCT's 705, 816, 818, 874, 1013,
1078, 1112, 1113

TEST ABLE

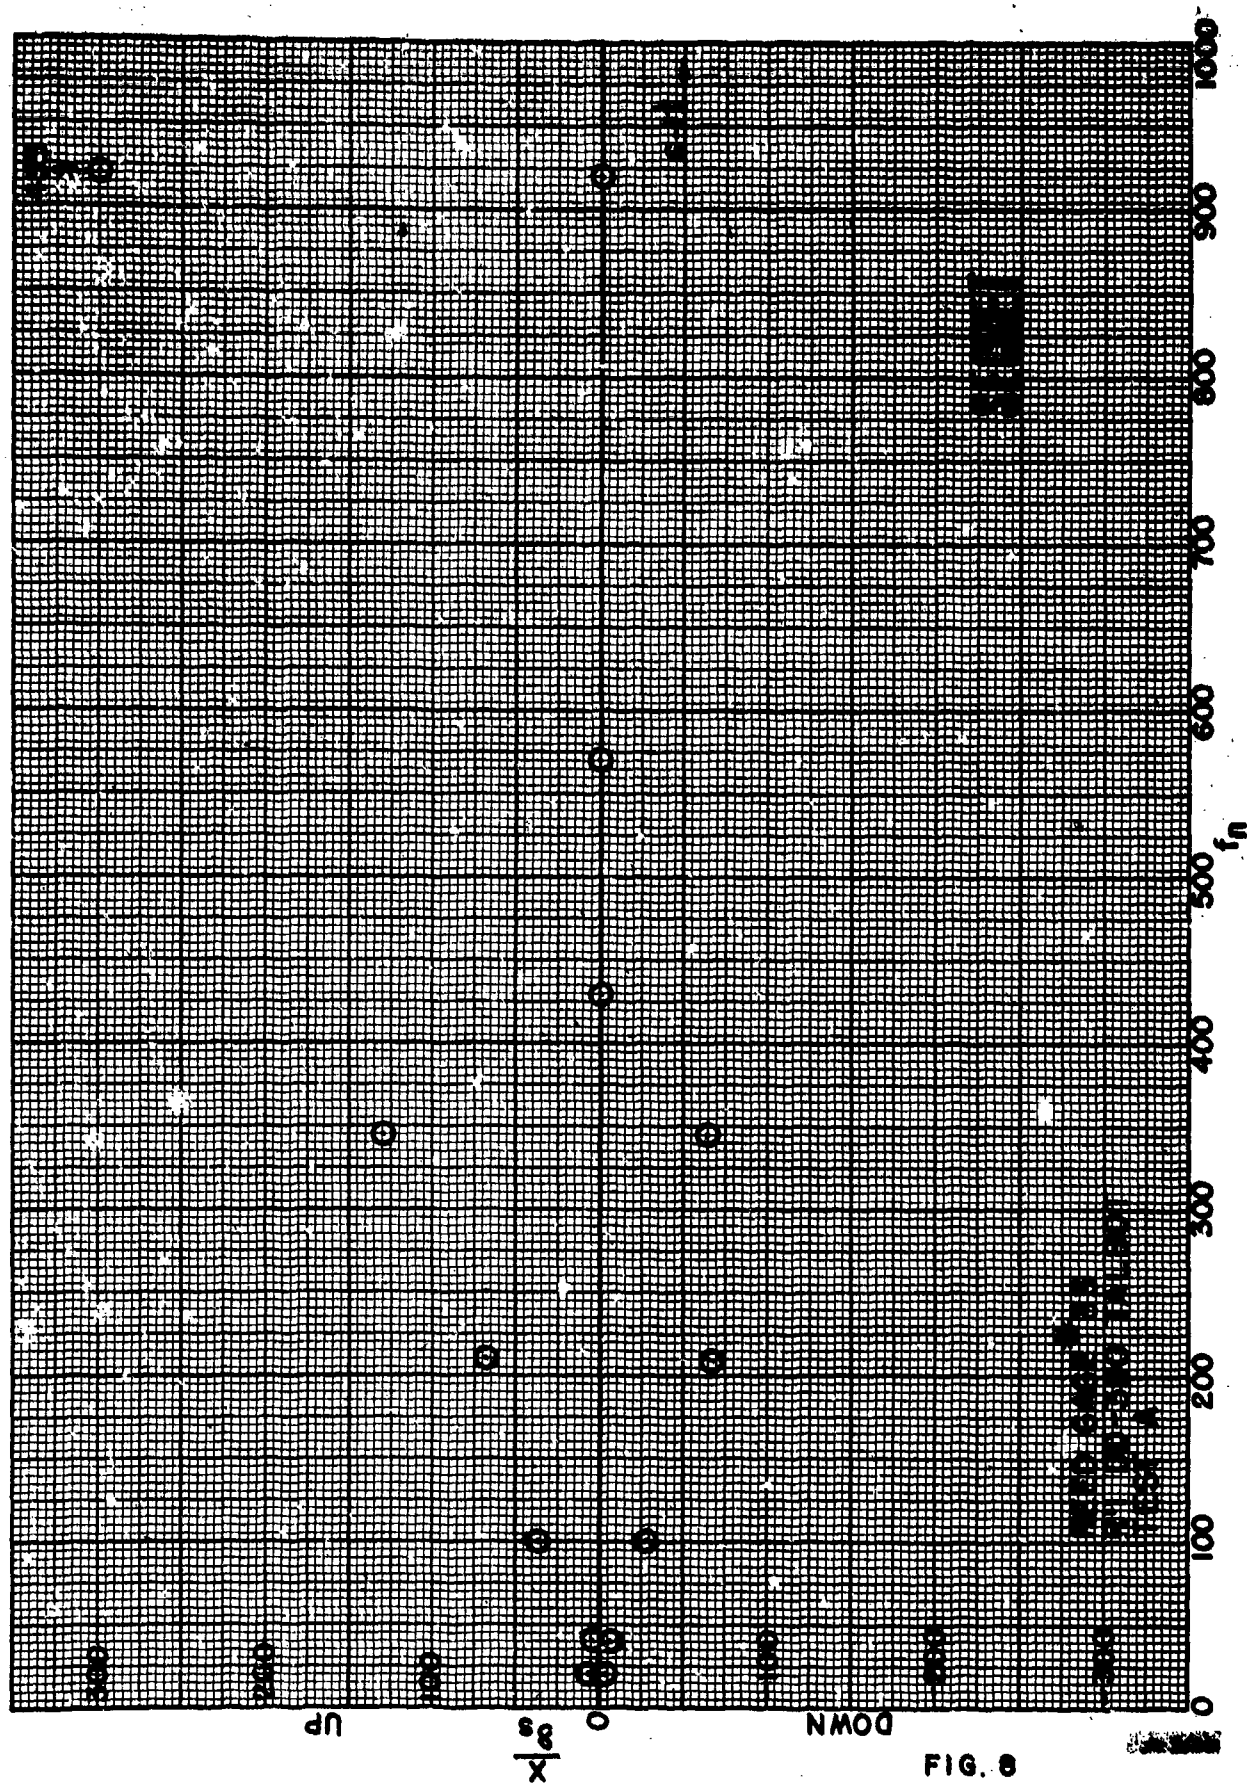
FIG. 8

The superstructure gages all show vertical accelerations of 100g. or less. Since the 100g. vertical reading occurred on the putty gage in the C.I.C. room and the exposed indenter gages read less vertically, it seems probable that the origin of the vertical shock was underwater pressure waves. Q1, exposed to air blast, had a 400g. horizontal reading; Q2 was shielded from air blast and had readings below 60g. Q3 was partially exposed to air blast and had a 220g. reading; and Q4 within the gun director had a 130g. reading. These readings indicate that shock due to both air and water blast waves was felt in the superstructure; the horizontal reading due to airborne pressure and the vertical due to waterborne waves. 100-300g. seems a fair figure to assign to shock in exposed ordnance equipment.

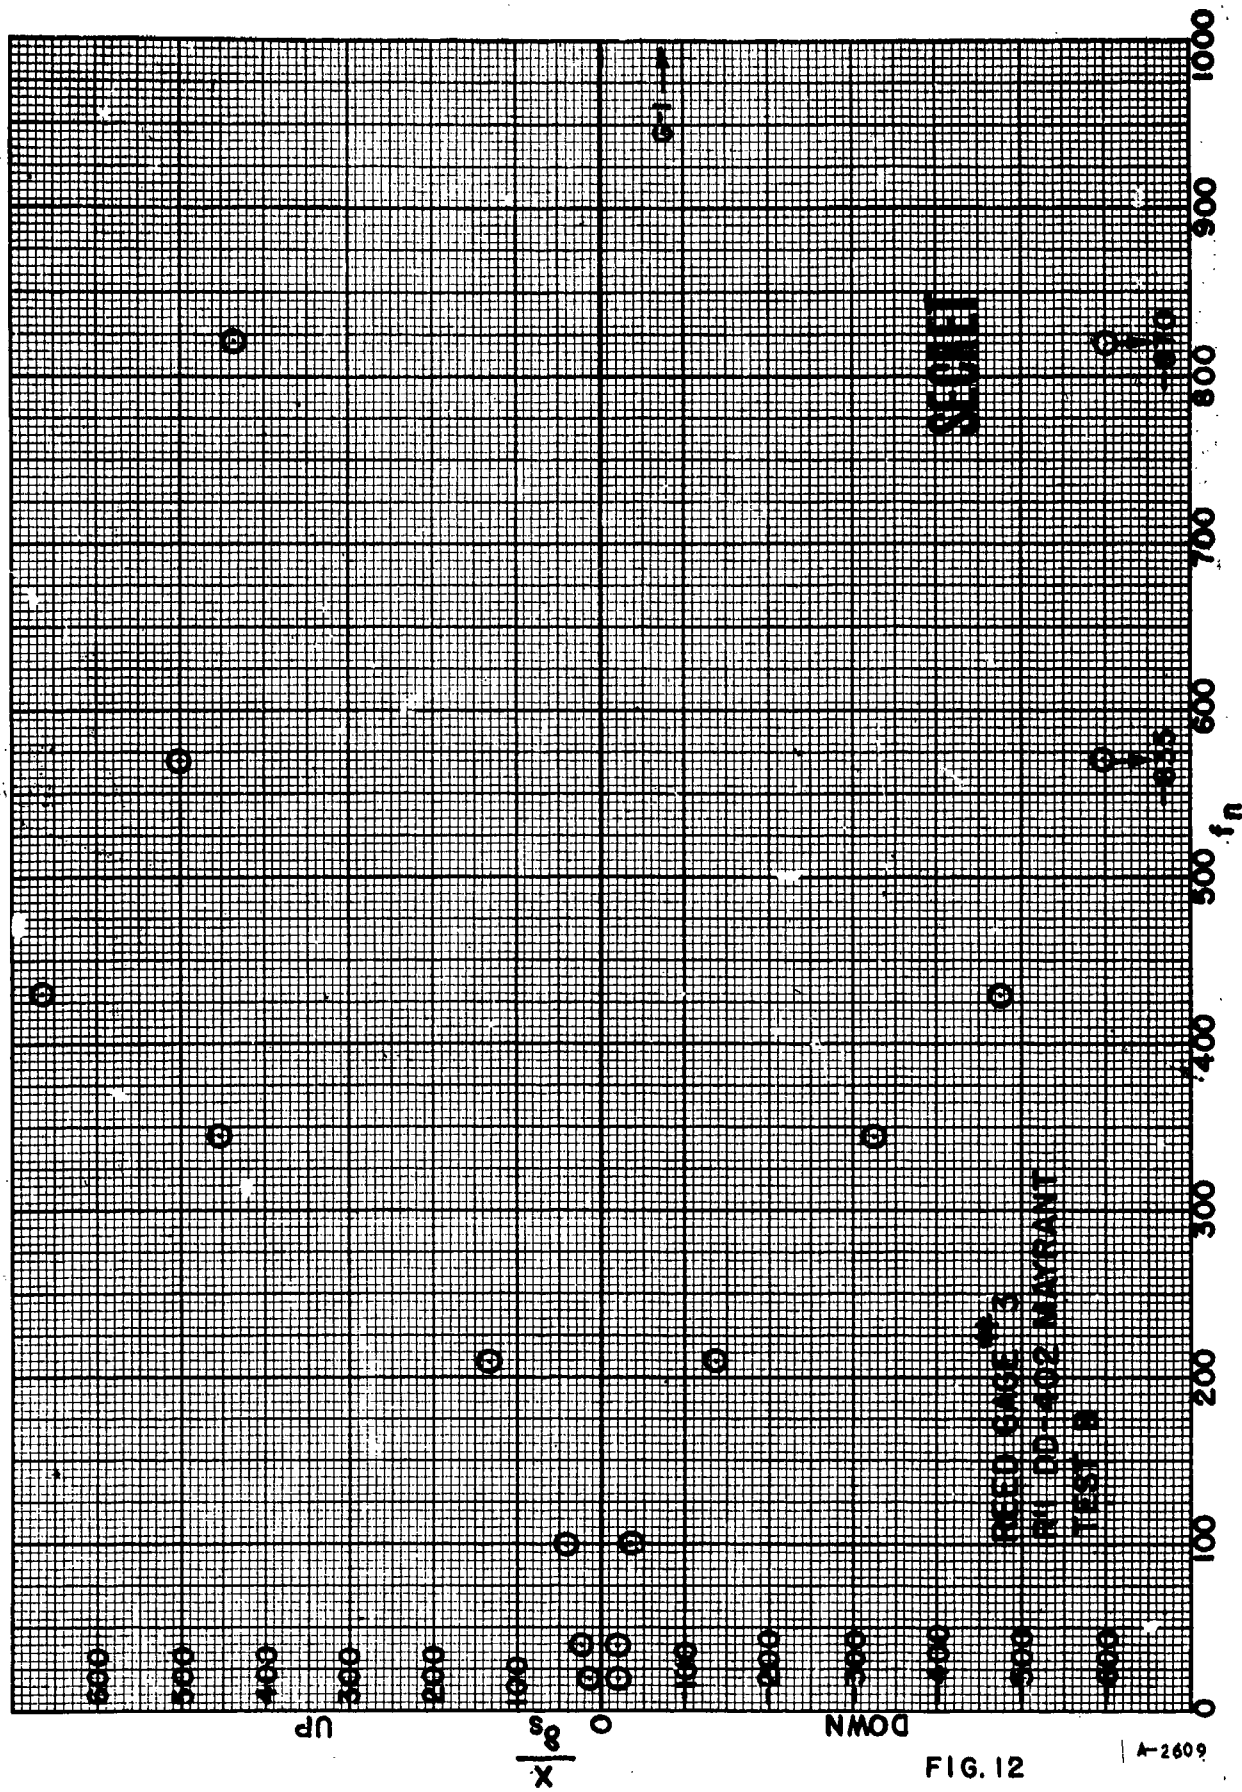
FIG. 12

In view of the high vertical putty gage acceleration of 300g. in the C.I.C. room, and the sizable deflections of R'1 on the hull, it is difficult to explain the low readings of the hull putty gages. D.S.M. reports a dishing of the starboard hull amidships, apparently due to the contact with tugs during decontamination, which makes the R'1 reading unreliable.

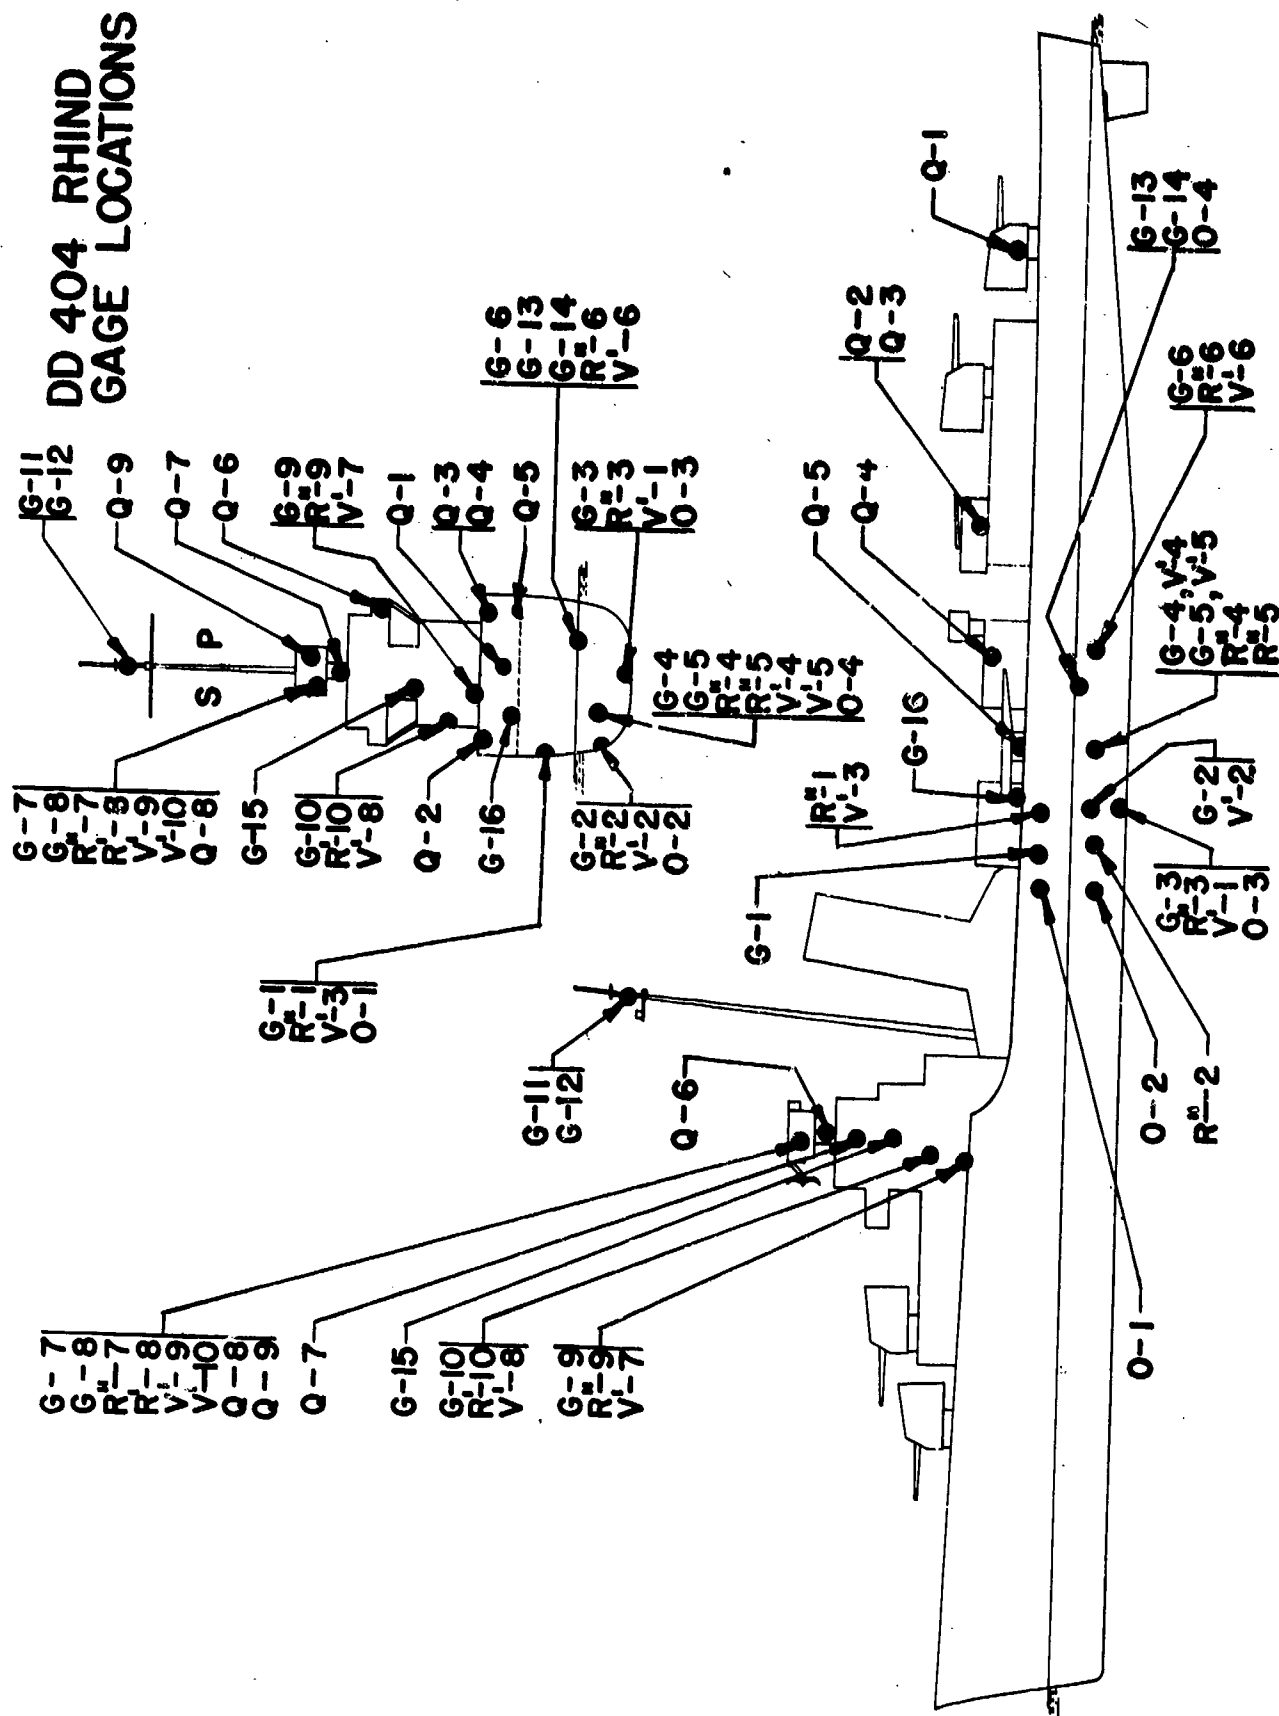
FIG. 14 A

All gages show no shock of intensity adequate to cause any readings. DSM reports no shock effects other than breakage of a few light bulbs.
